Aviation Safety

Letter

Issue 2/2001

Mid-Air Collision

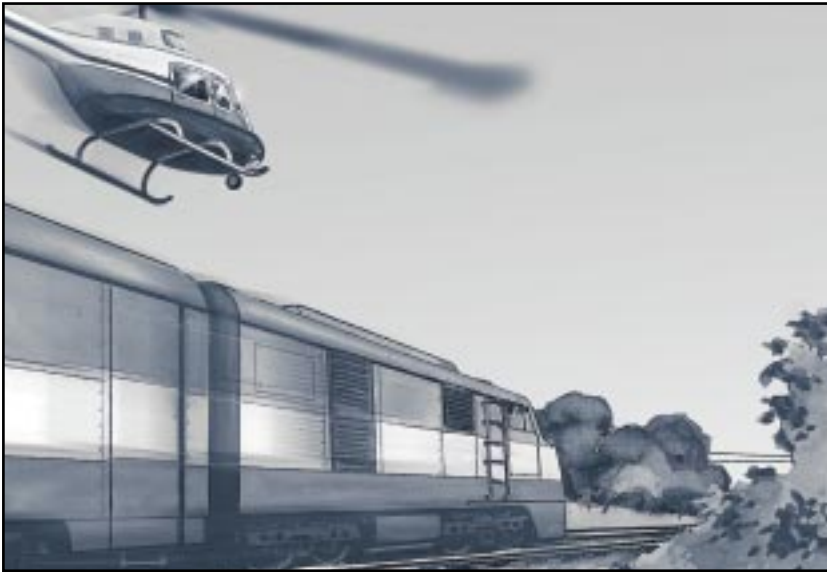
Artist's impression of moment before the wire strike

On February 26, 1999, the pilot and a two-person film crew were conducting an aerial photographic flight to film train traffic in the area near Hinton, Alberta. As a train approached Entrance, Alberta, about five miles west of Hinton, the pilot manoeuvred the helicopter over the train cars. Once directly over the cars and about 40 cars behind the locomotives, the pilot descended the helicopter to a skid height of about 12 ft above the rolling stock and adjusted his flight speed so that he was slowly overtaking the locomotives. About 30 seconds into the film run, the helicopter struck two steel electrical wire conductors that crossed the rail line at a 90° angle. The wires contacted the helicopter just above the windshield and moved aft into the pitch control rods and main rotor mast. The pitch control rods were severed and aircraft control was lost. The aircraft pitched up, yawed left, then right, and descended in a 45° nose-down attitude, striking the ground about 90 ft left of the passing train and about 600 ft beyond the point where the wire strike occurred. All occupants of the aircraft were wearing both lap and

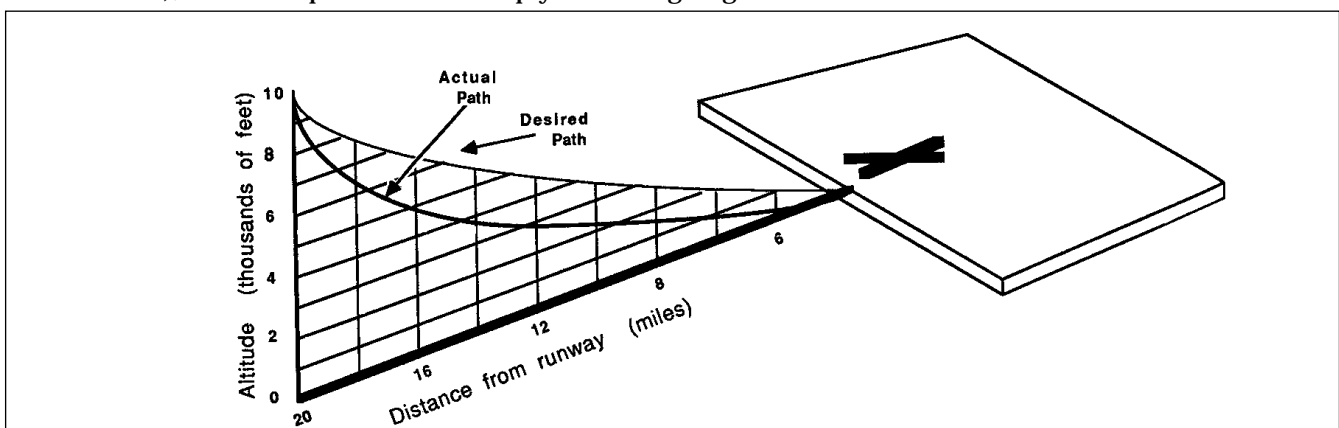
Comparison of the approach path flown by pilots during a night visual approach with the desired altitudes. Altitude is in thousands of feet; distance from the runway is in miles. (After Kraft, 1978.) Illustration reproduced from *Human Factors in Aviation* by Earl Wiener and David Nagel, Academic Press Inc., 1988, with permission.

Finally, there is an increased risk of inadvertent flight into instrument meteorological conditions (IMC) at night. Even though an estimated 10% of VFR flight activity occurs at night, a full 30% of VFR-into-IMC acci-
